# Aurora Home Inspection

## CONFIDENTIAL INSPECTION REPORT

123 Elm Street, Kenilworth, NJ 07033

3/15/2006 9:00 am to 11:30 am

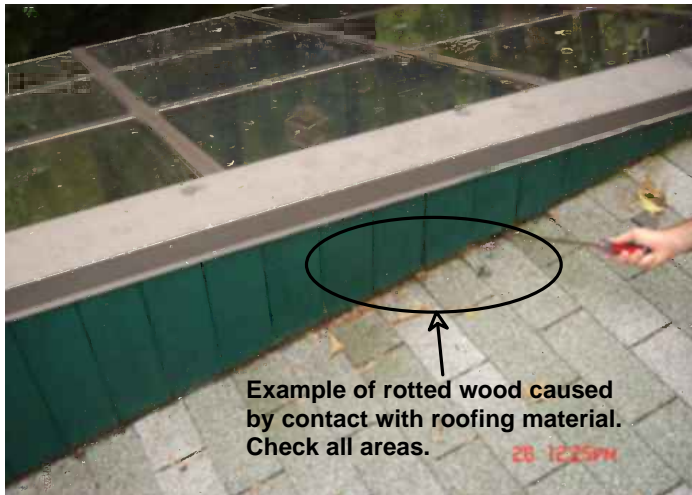
- The wooden siding is close to, or in contact with the roofing material. Wooden products are vulnerable to rot and wood-destroying insects when they are close to or in contact with the roofing material. The bottom of the siding should be one inch above the roofing material.
  - See Attached Illustration 1

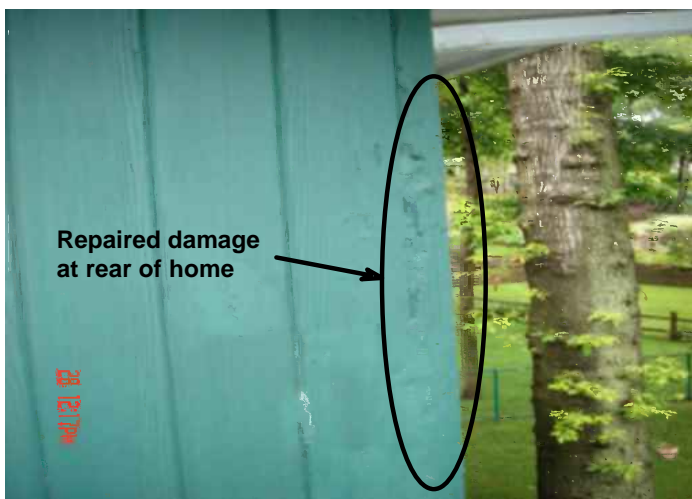
- There are areas of the siding that were damaged and repaired with a wood-putty like material. It is recommended that the owners be asked to explain this. The causes may include insect damage and rot. Please make sure that the causes for this damage have been corrected.

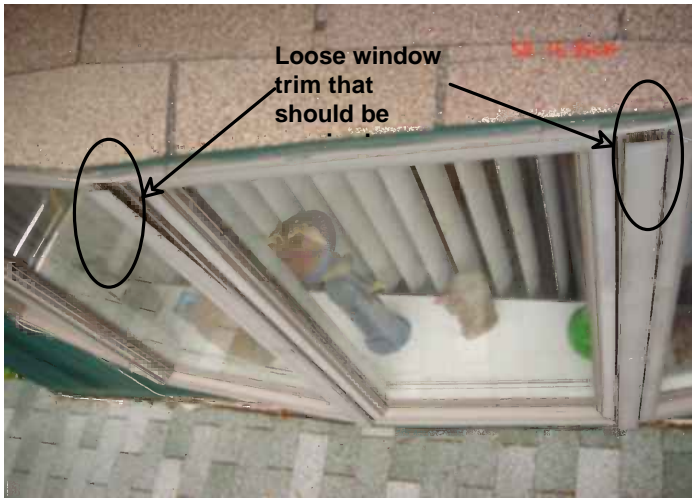
- The window-trim, and particularly that on the south facing side that is exposed to direct sunlight, is in poor condition and needs to be serviced.

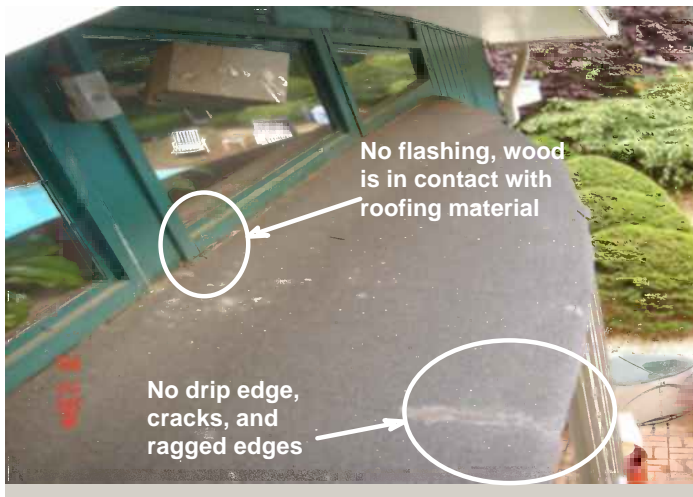
- The small roof over the living room bay window is deteriorating and should be replaced. This area has rolled 90-pound cap roofing material, which has a life span of 10-15 years. The roofing in this area is cracked may be prone to leaking. Also not that the siding touches the roof in this area, as it does in several other areas. This causes the siding to absorb water and rot.

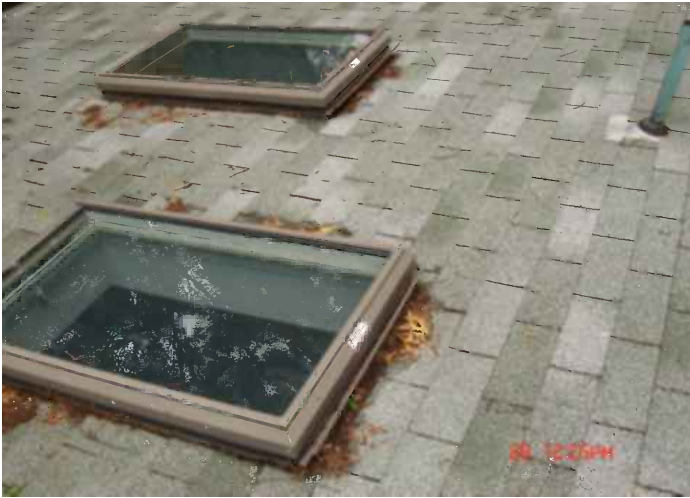
- The roof includes one or more skylights, which are notoriously problematic and a common point of leaks. There are different methods of installing them and, although opinions will vary, some methods are better than others. Therefore, it will be important to keep the area around them clean and to monitor them for evidence of leaks.
- Debris is building up in the area around the skylight which needs to be cleaned and monitored.

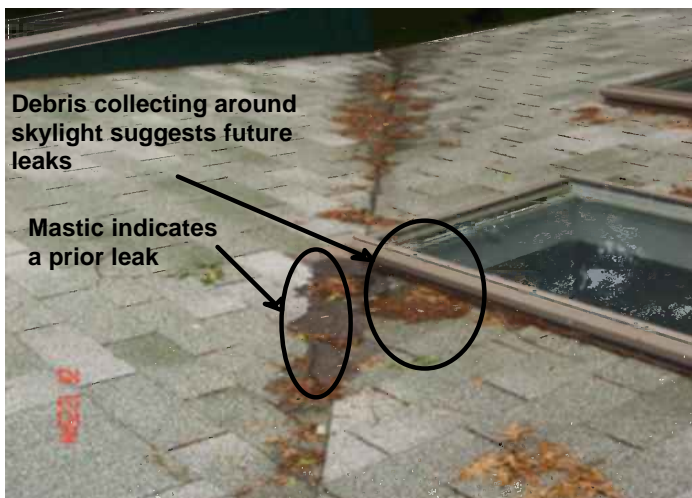
- Some mastic has been applied around the skylight, and inasmuch as approved installation methods do not include the use of mastic its presence is either indicative of an amateur installation or a confirmation of leaks. It would be prudent to ask the sellers about this or have a specialist evaluate. Regardless, the skylight should be monitored.

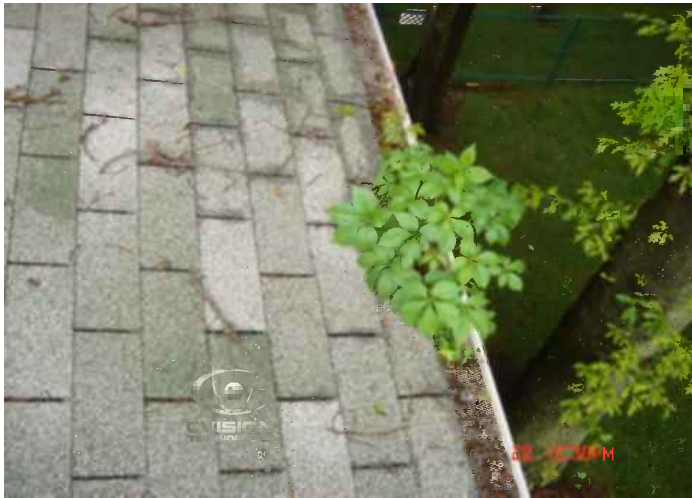
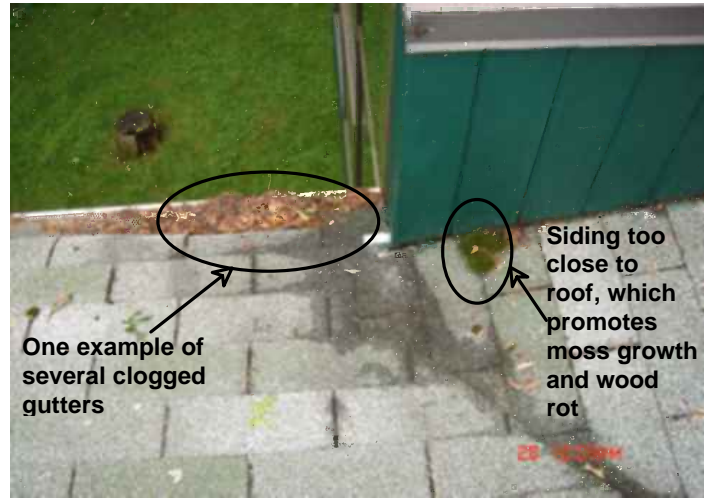
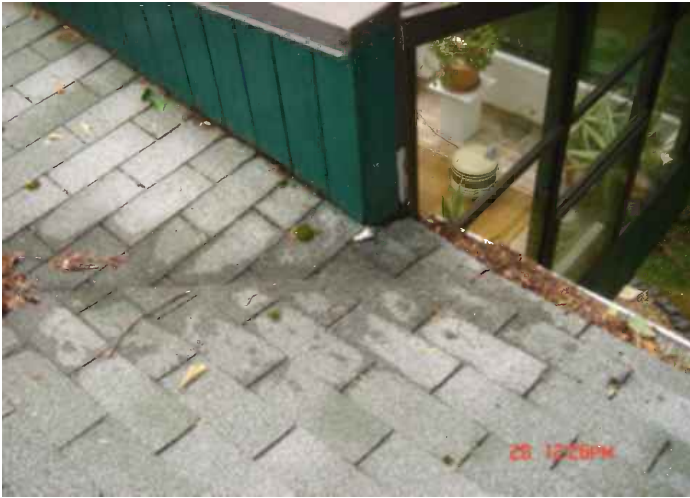
- The gutters need to be cleaned and serviced to drain properly.

- The roof needs to be cleaned and any foliage trimmed away to facilitate drainage.
- Gutter leaf screens are clogged and falling into the gutters and should be removed. Screening on the gutters is sometimes successful, but in many cases, the screening falls into the gutter and traps leaves and twigs. In this case, the gutters actually clog more quickly. We recommend that the gutter screens be removed and that the gutters be cleaned twice a year.

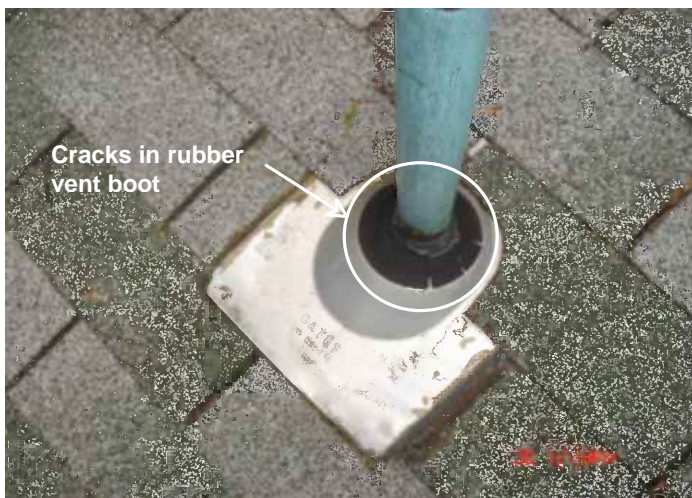
- The rubber boots on the plumbing vents are deteriorated and should be replaced by a licensed roofing contractor. Further deterioration could lead to leaks.

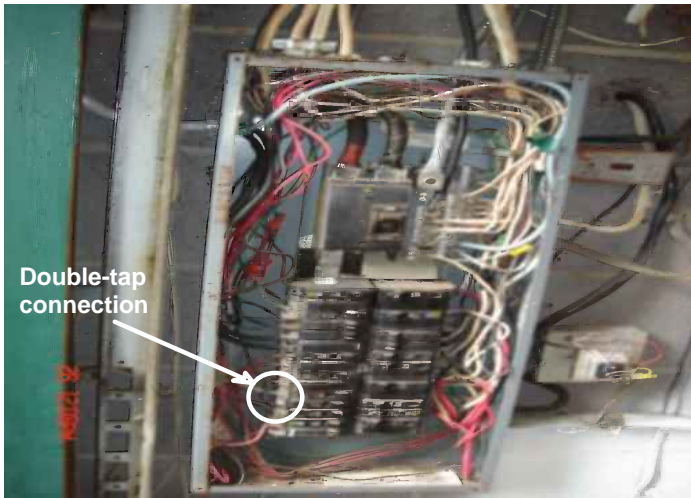
- A breaker is serving two circuits, which could overload the circuit, and there is no room within the panel to add additional breakers. This condition should be evaluated by an electrician.

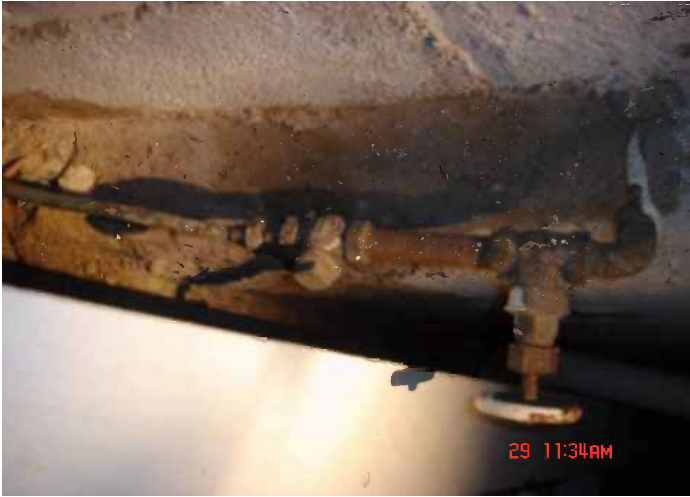
- There are abandoned oil lines in the basement that should be removed.

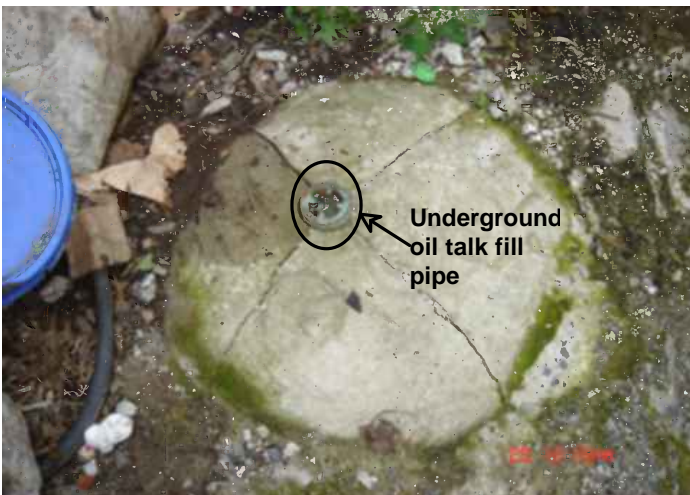
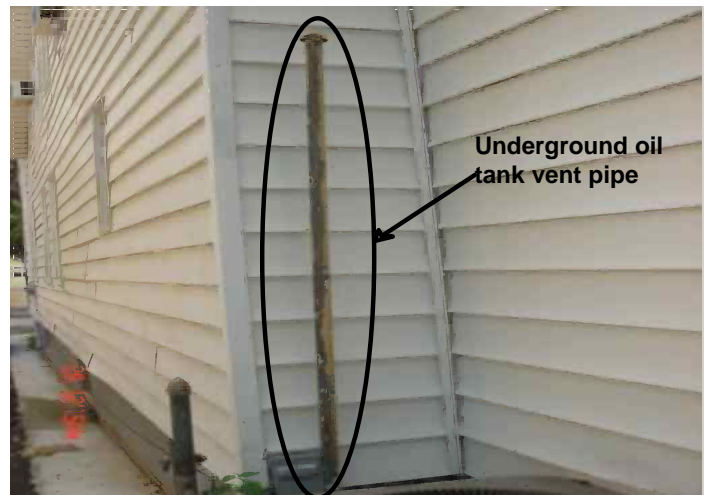
- Fill and/or vent pipes for an abandoned oil storage tank were found, indicating that the tank was not properly abandoned. It is critical that all abandoned oil storage tanks be properly abandoned and documented as such. If a tank is found at some later time, the current owner of the property is responsible for removing the tank and for correcting any environmental damage caused by the tank. Also, fuel delivery drivers can mistakenly deliver oil to an abandoned fill pipe, which could contaminate the soil or cause the basement to be filled with oil.

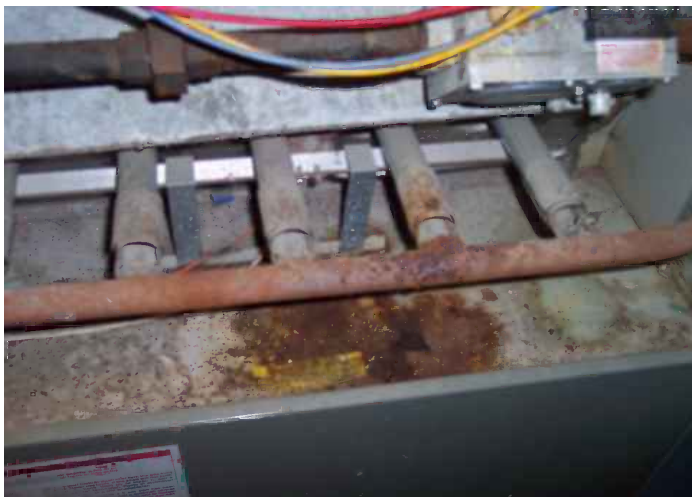
- Rust particulates are accumulating below the burners in the combustion chamber of the gas furnace. They are typically caused by condensation, but should be removed before more particulates gather and smother the burners.

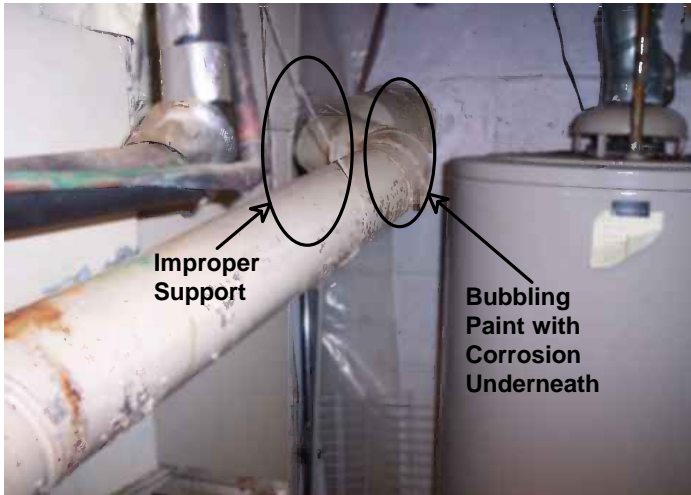
- The vent pipe is painted which is not recommended. The paint could be covering corrosion that would allow exhaust gases into the home. The vent pipe can be several hundred degrees, which is too hot for house paints. The paints will eventually bubble up and come off. We do not know what kind of paint was used, but we feel that it is possible that when the furnace is operating, unpleasant and possibly noxious fumes may be released.

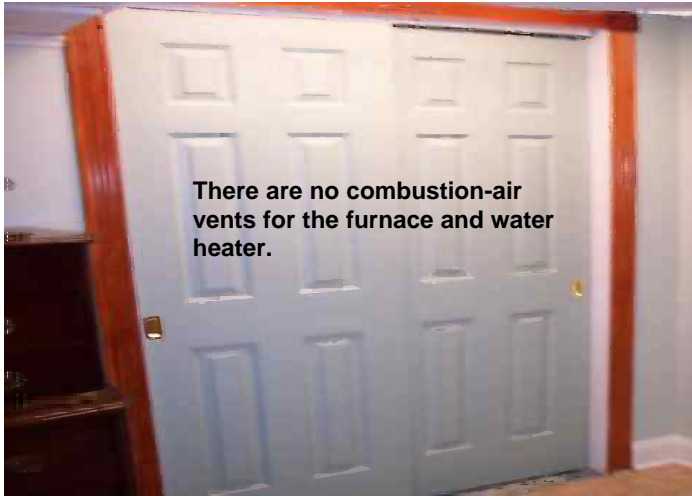
- There are no combustion-air vents within the furnace closet to support the combustion process, which are essential to ensure that the circulating air does not become contaminated by carbon monoxide, and this negative condition should be corrected as soon as possible. One consequence of this condition could be back-drafting, where air flows down the chimney rather than up. Evidence of back-drafting includes rust, dust, soot, etc. at the ends of the vents near the water heater, furnace, etc.

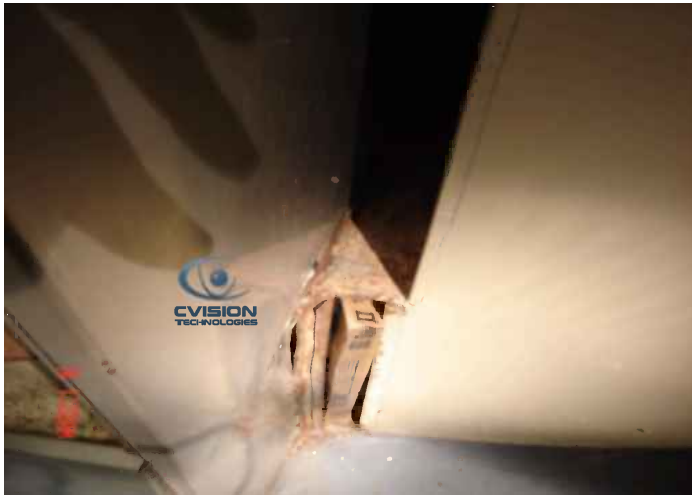
- The filter in the return air compartment is the wrong size or type, which can allow particulates to pass beyond the filter and compromise the system.

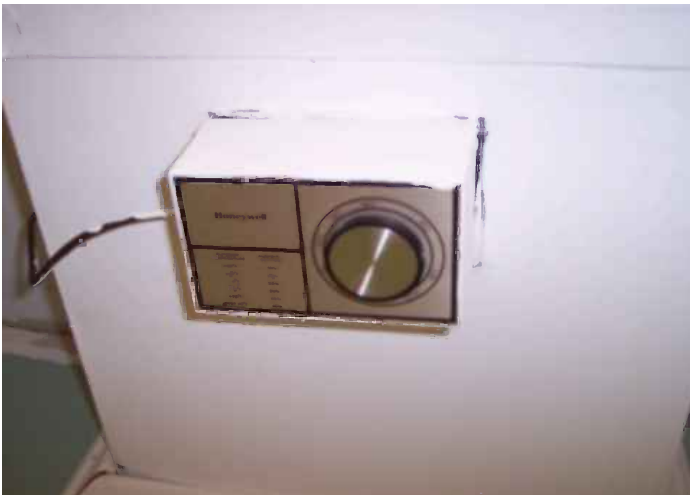
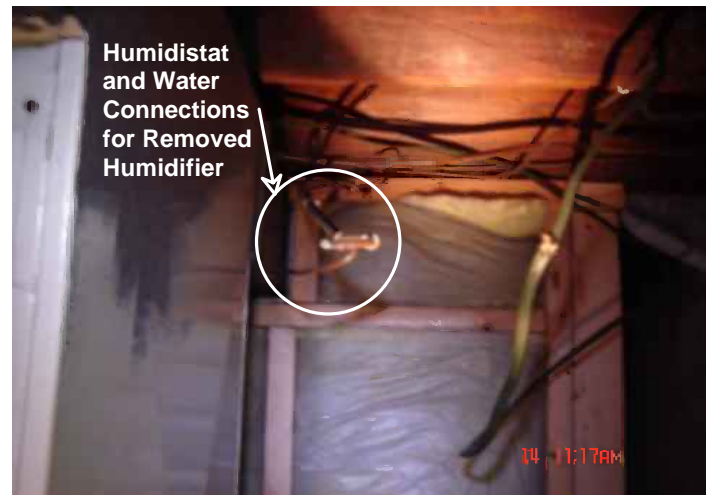
- There are controls and connections for a humidifier but it has been removed.

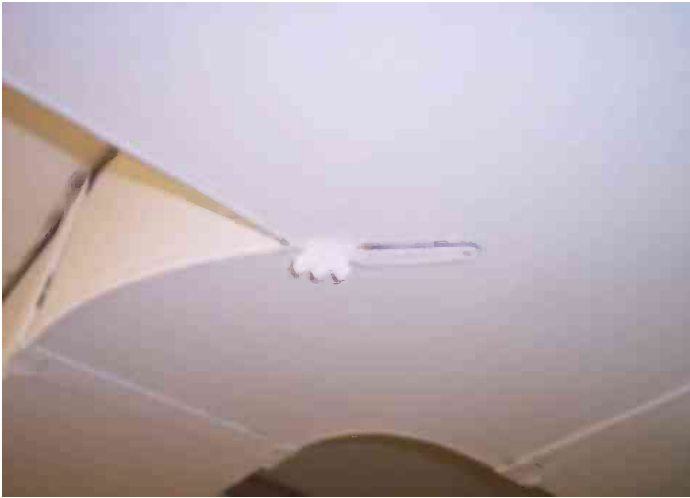
- A damper control in the basement is stuck due to paint.

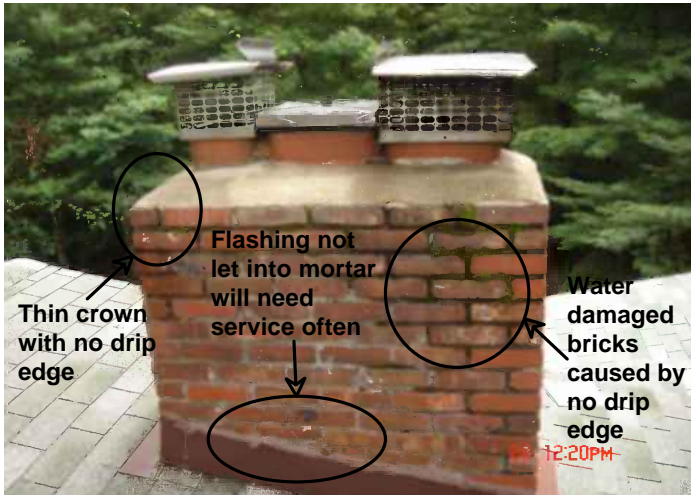
- The mortar on the crown is not contoured correctly to shed water, which is its intended purpose, and should be serviced.
  - See Attached Illustration 2

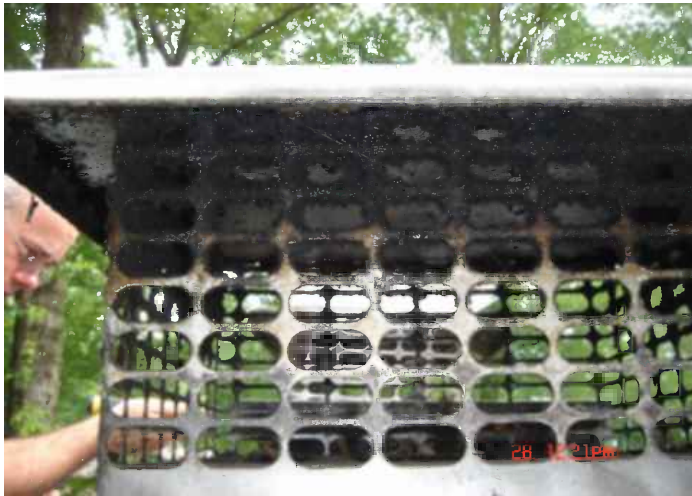
- Chimney flues need to be periodically cleaned to prevent the possibility of chimney fires. However, the complex variety of deposits that form within chimneys are not easily understood. They range from pure carbon, which does not burn, to tars that can ignite. All of these deposits are commonly described as creosote, but creosote has many forms, ranging from crusty carbon deposits that can be easily brushed away, to a tar-glazed creosote that requires chemical cleaning. These deposits should be identified and treated by a specialist. However, cleaning a chimney is not a guarantee against a fire. Studies have proven that a significant percentage of chimney fires have resulted within one month of the chimney being cleaned, and many more have resulted within a six-month period.

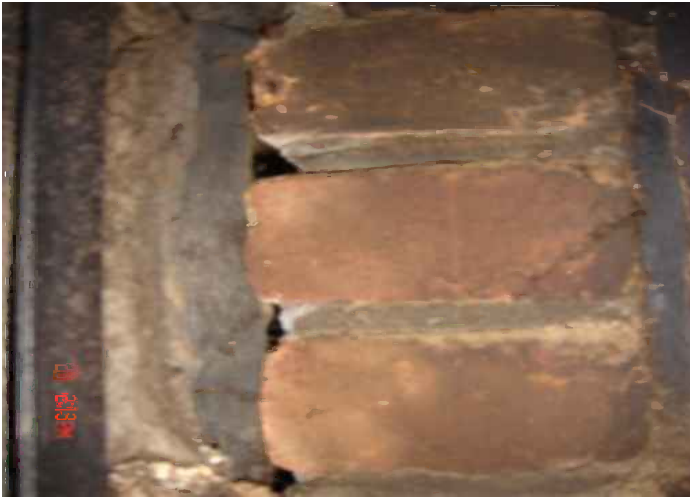
- √ There are cracks, loose bricks, or missing mortar in the refractory bricks of the fireplace, which is not uncommon, but which should be serviced by a licensed chimney sweep. The implication of this is that heat and flames could get into the wall and possibly start a fire.

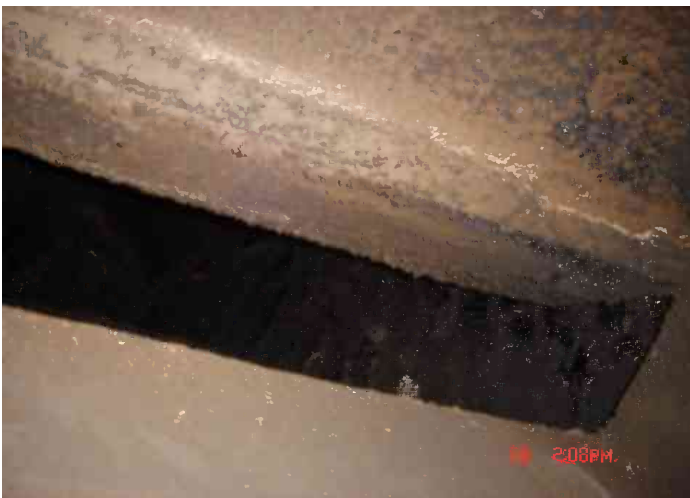
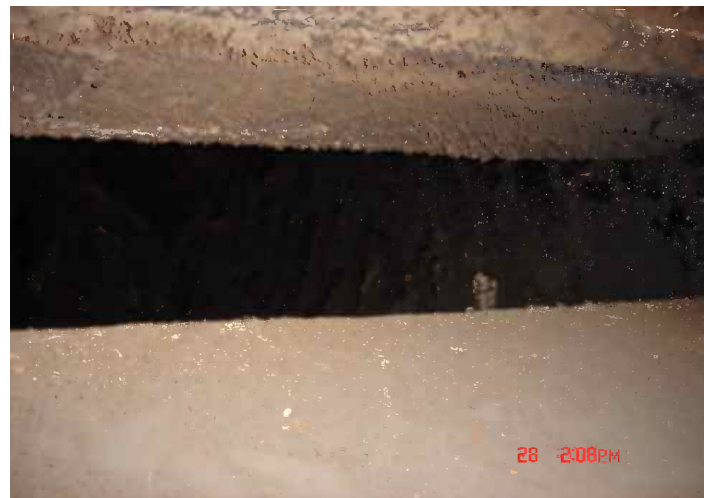
- There are creosote deposits in the fireplace that could lead to a chimney fire. The chimney should be cleaned by a specialist and serviced as necessary before using the fireplace. These deposits are often caused by burning low-quality, green, or soft wood, such as pine. Be sure to use properly seasoned hardwood in all fireplaces.

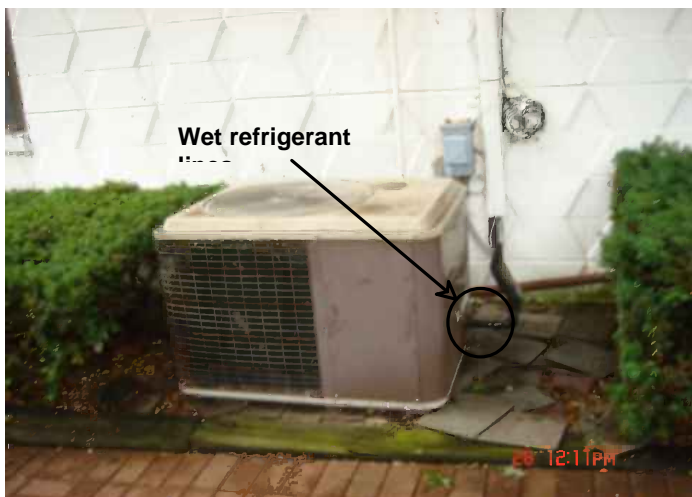
- There was an unusual amount of condensation on the refrigerant lines that should be monitored. We do not think that the lines are leaking, but because the unit is under a service contract, you may want to ask the company and perhaps schedule a free service call.

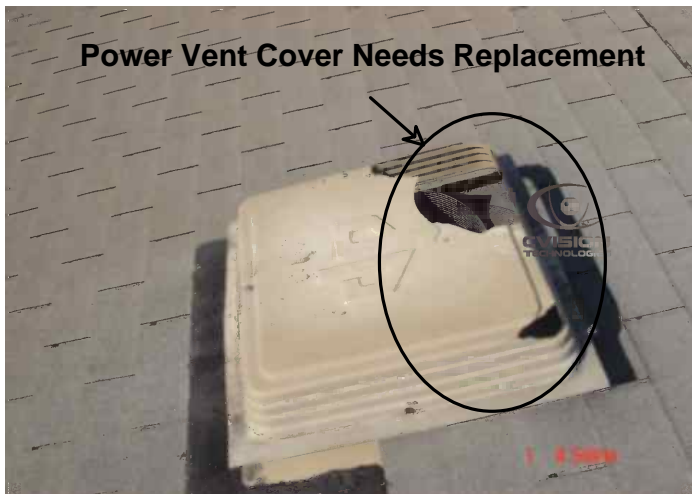
- The power ventilation port screens are damaged, which will allow rodents or other pests to enter and contaminate the area.

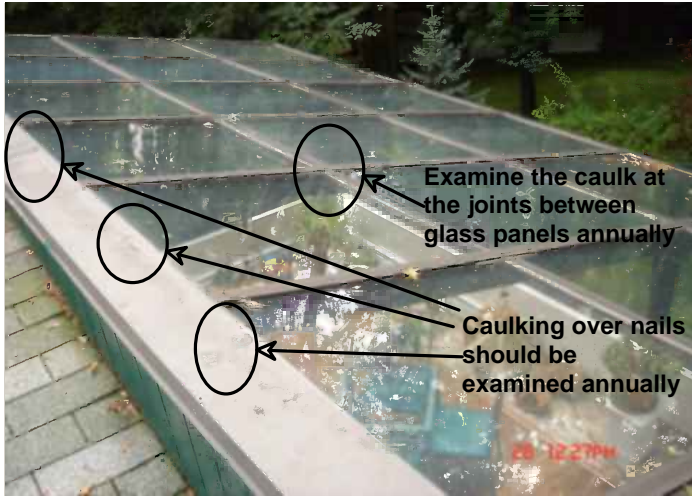
The sloped glazing is susceptible to leakage because the water gets hung up on the lips and edges supporting the glass. Flashings at curbs and solarium/wall intersections are also common leak spots. Wooden trim and framing is especially susceptible to rot. The caulking on the flashings need to be carefully inspected each year and repaired as necessary.

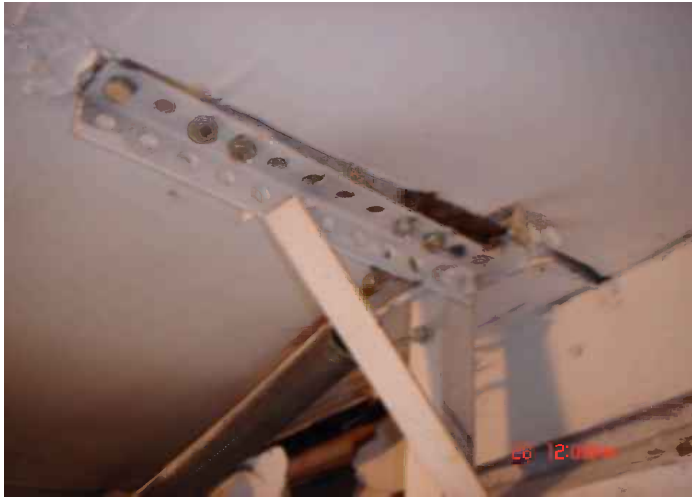
- One or more of the garage door tracks are not securely attached and should be serviced. The garage door springs place a tremendous load the tracks, and if they come loose, serious property damage or injury can occur.

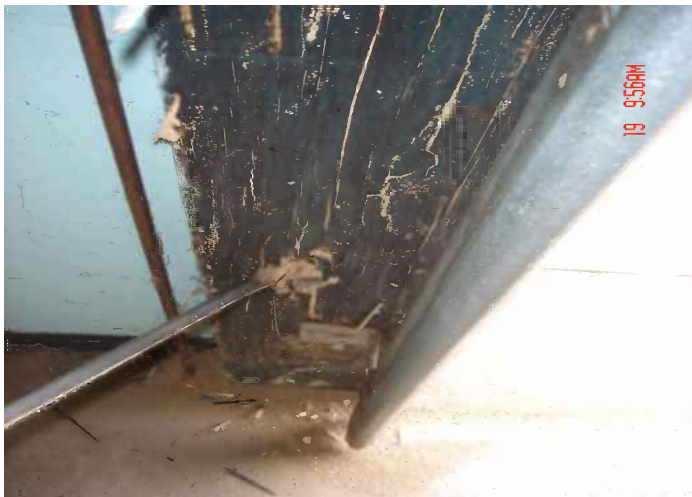
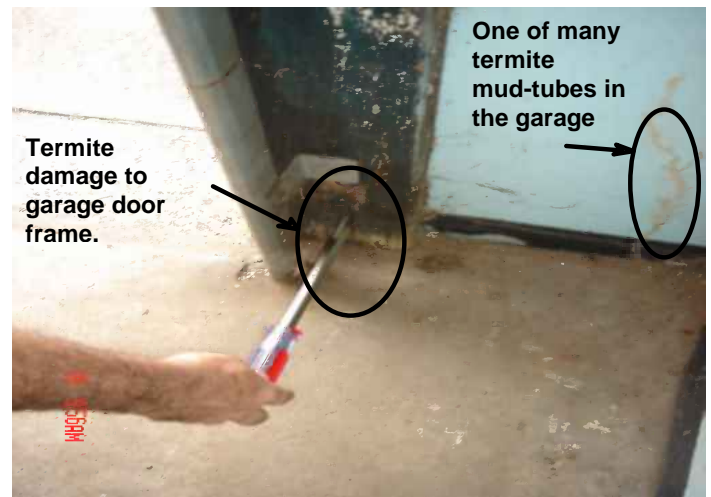
- √ There is termite damage in and around the garage door which should be further evaluated by a licensed exterminator. There is also an ant infestation, and many termite mud-tubes in the garage.

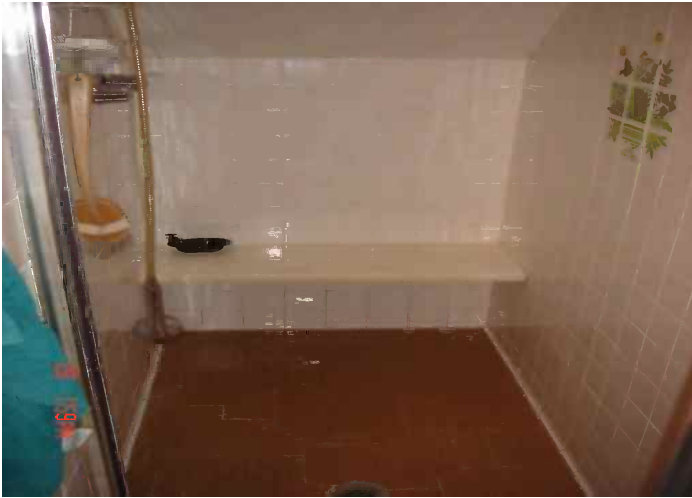
- The hand sprayer is a replacement and does not fit in the holder and should be replaced.

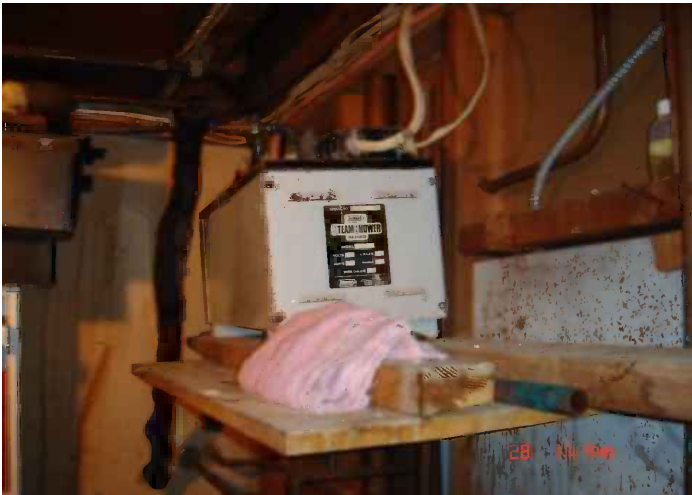
- The steam shower needs to be serviced, for the following reasons: The steam generator does not work and is rusty.

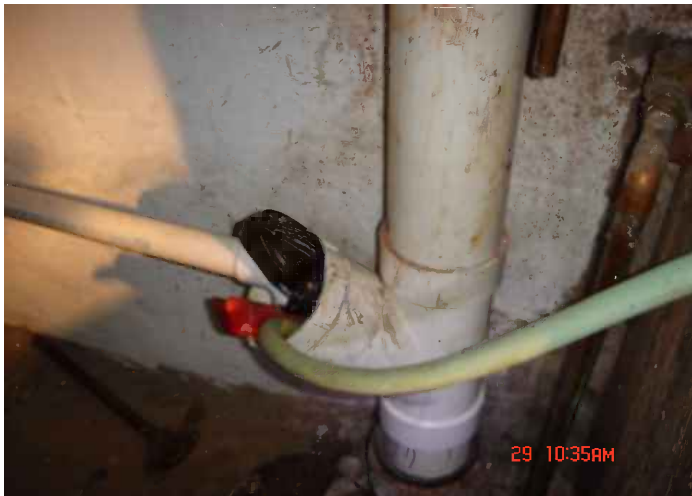
- The washer discharges into a sewer clean-out, rather than a standpipe with a trap. Because the sewer clean-out is left open, sewer odors can enter the home.

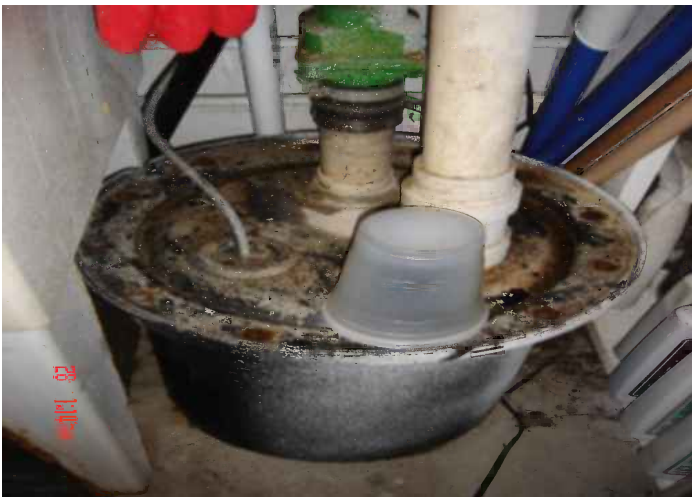
- Pump is rusty and shows signs of aging.

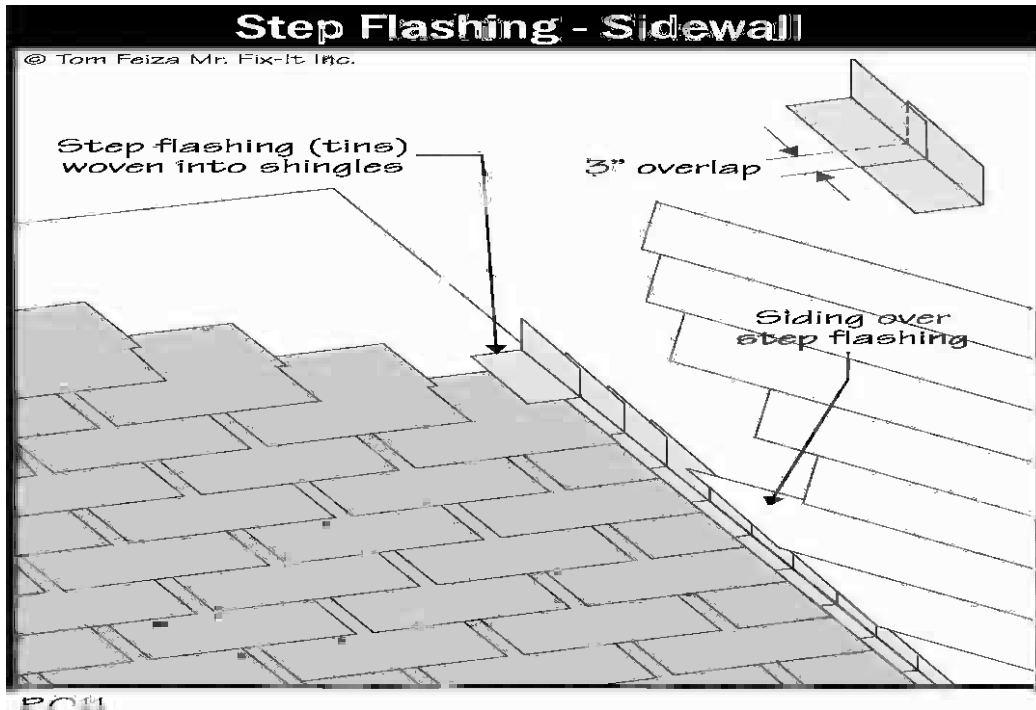
Illustration - 1 The wooden siding is close to or in contact with the roofing material

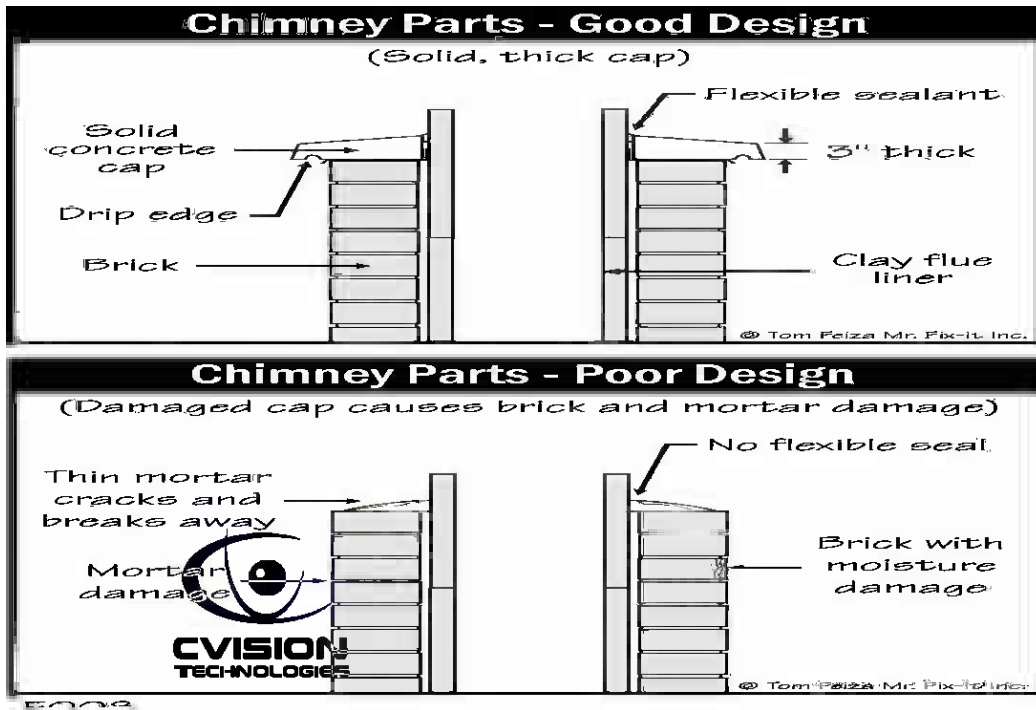
Illustration - 2 The mortar on the crown is not contoured correctly to shed water which is its intended purpose

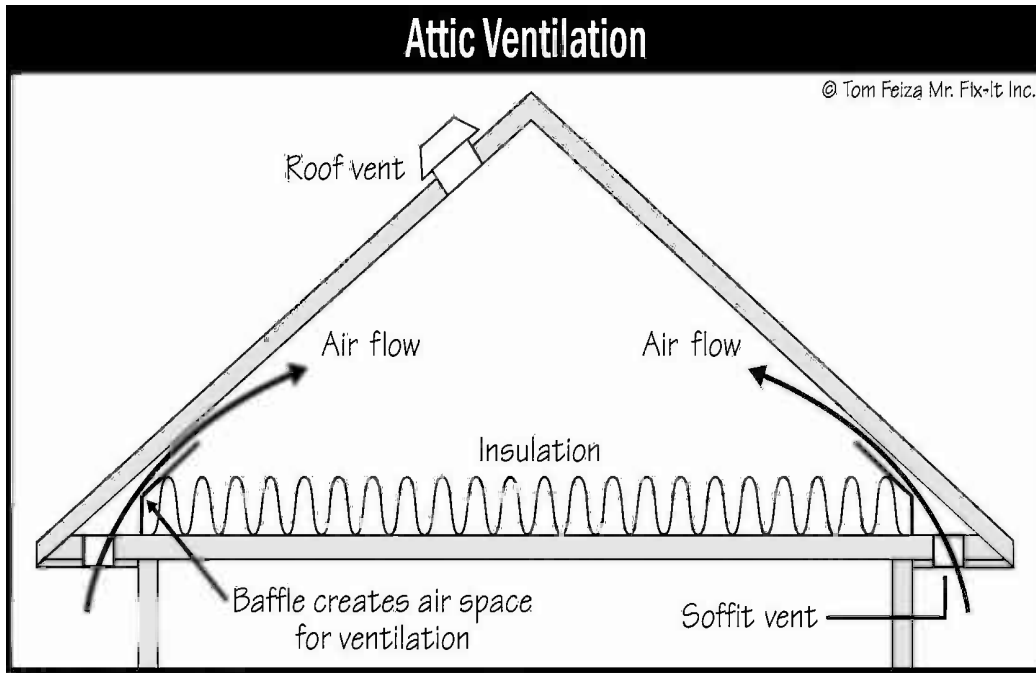
V002

- The soffit vents are covered with insulation, which limits ventilation and causes high heat in the attic. This heat could contribute to premature failure of the roof covering.

Illustration - 3 The soffit vents are covered with insulation

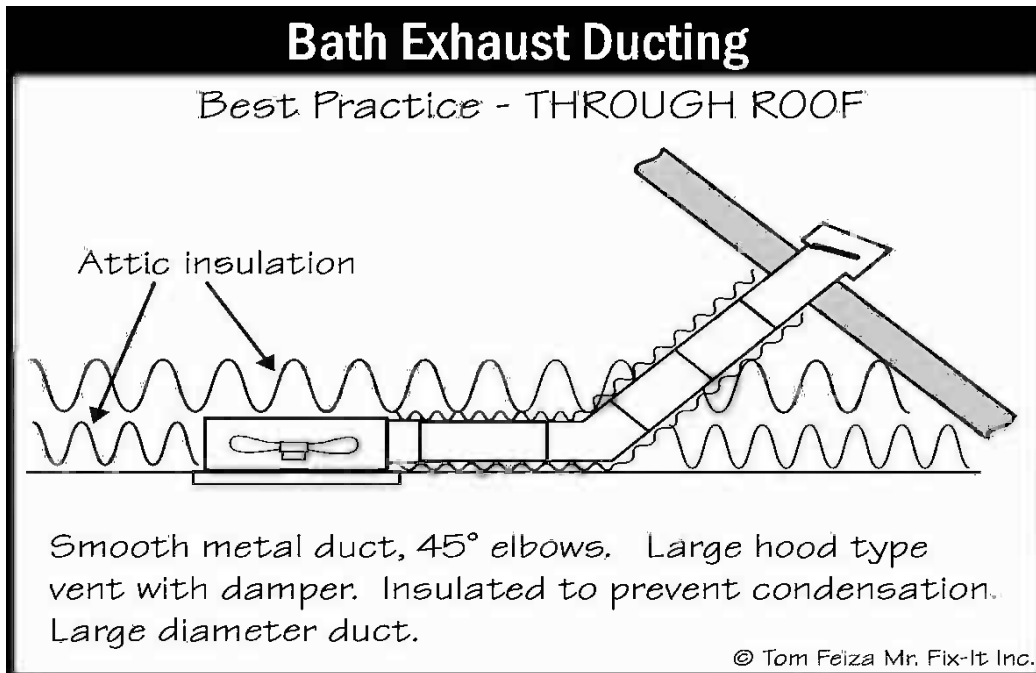
V019

Illustration - 4 The bathroom vent fan is covered by insulation in the attic

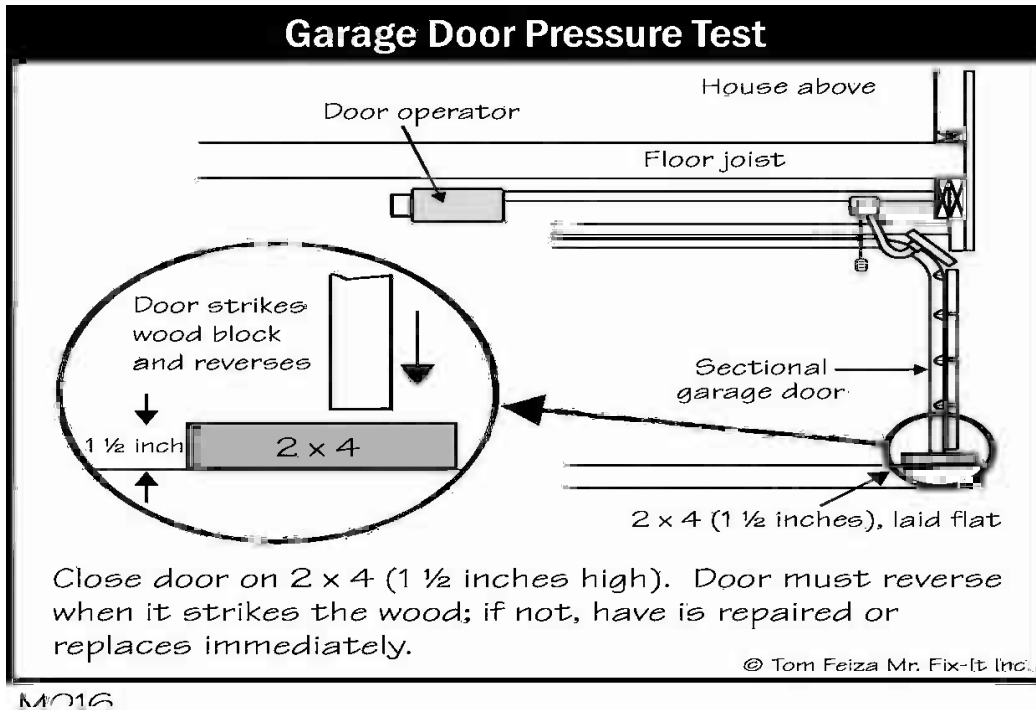
M016

Illustration - 7 One or more openers is functional but does not auto-reverse or may need to be adjusted
